AGRIUM KAPUSKASING PHOSPHATE OPERATIONS LAND RECLAMATION

Description of Work: Scarification and direct broadcast seeding of mine waste materials (rock, clay and till) with erosion control seed mix and native seed mixes. Rock pile, clay pile, plant site and pit shorelines were directly revegetated without adding soil cover over waste mine materials greatly reducing the cost of reclamation. Initial 2014 work was fully warranted at the owner's request with a supporting 5 year performance guarantee bond. Bond was dissolved in 2019 without any claims due to vegetation still performing very well. As multiple years worth of thick nitrogen fixing vegetation is composting, a layer of organics soil is now starting to build up all over the mine site.

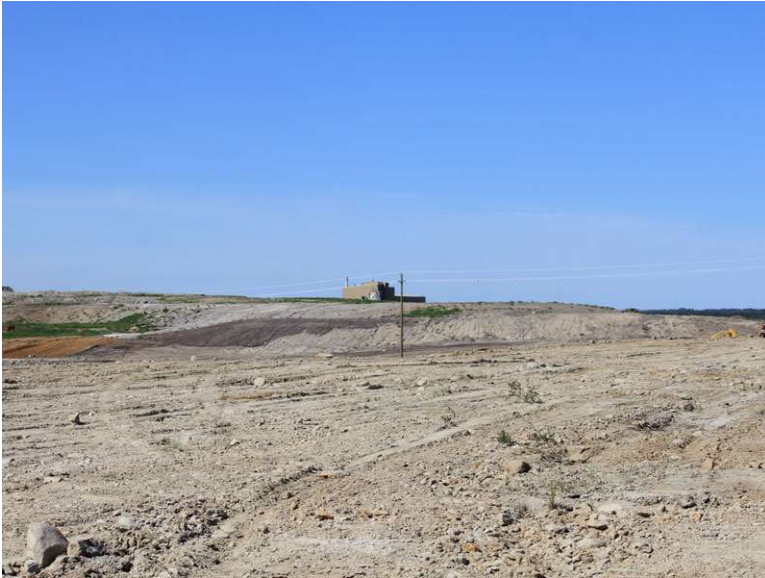
Waste rock clay and till following rough grading by earthworks contractor.

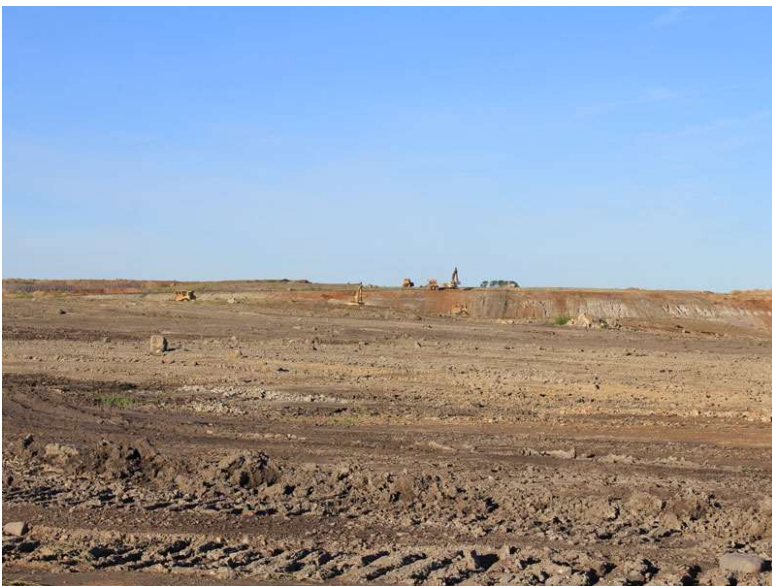
Typical conditions prior to seeding. Soils include a range of waste rock, clay and till but contain no organic content. The soils are generally non acidic and were directly revegetated.

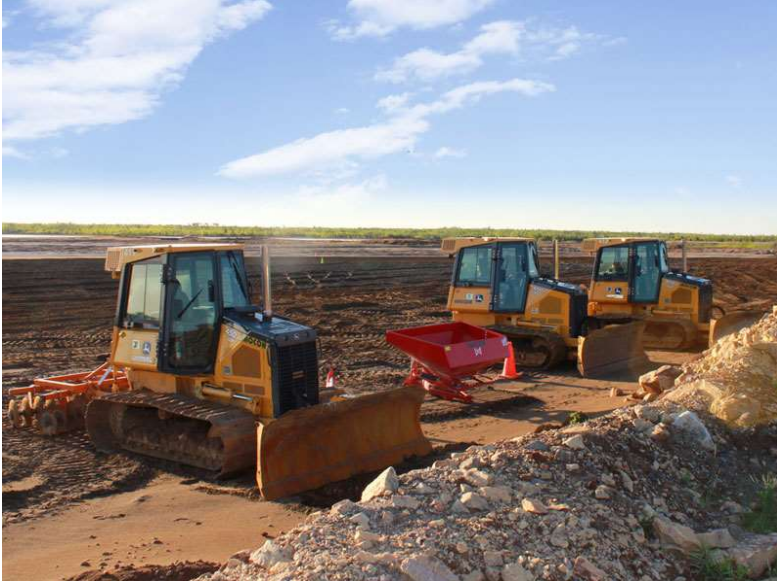
Seeding equipment primarily consisted of three John Deere 450 dozers equipped with 3 point hitches, chain harrows, Lely broadcast seeders and GPS units.

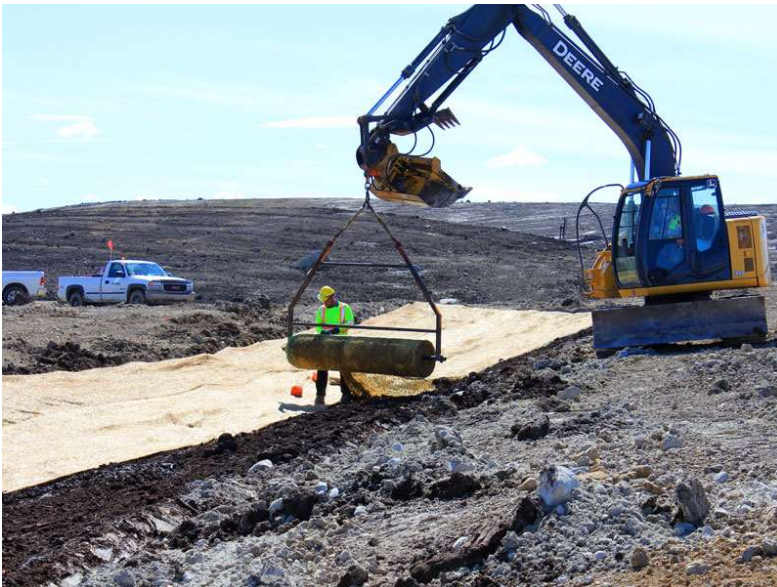
Installation of Erosion control blanket within vegetated channels. Blanket was fully keyed in at edges and placed in intimate contact with the soil.

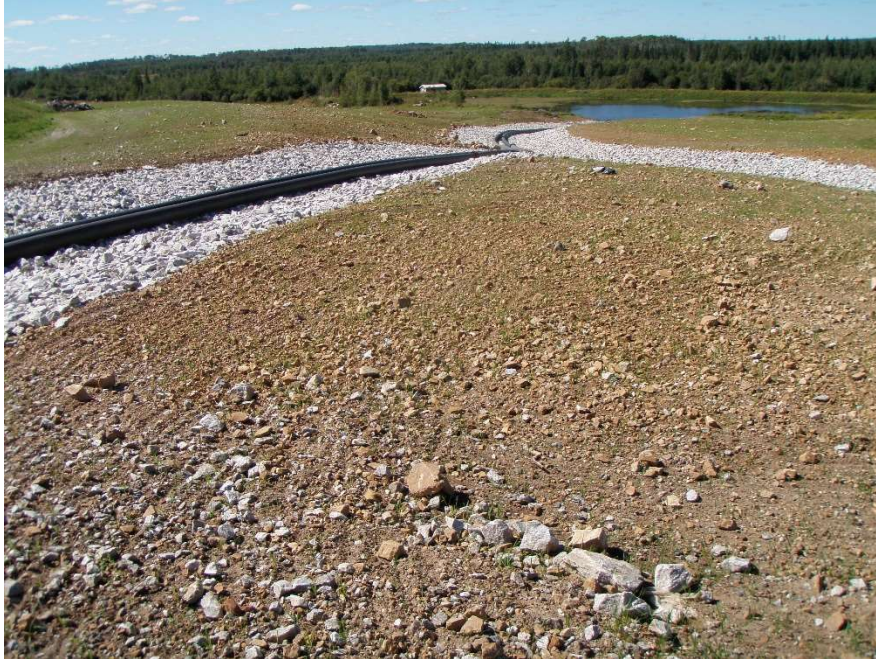
Early growth of rocky area. Scarified with JD450 LGP and chain harrows.

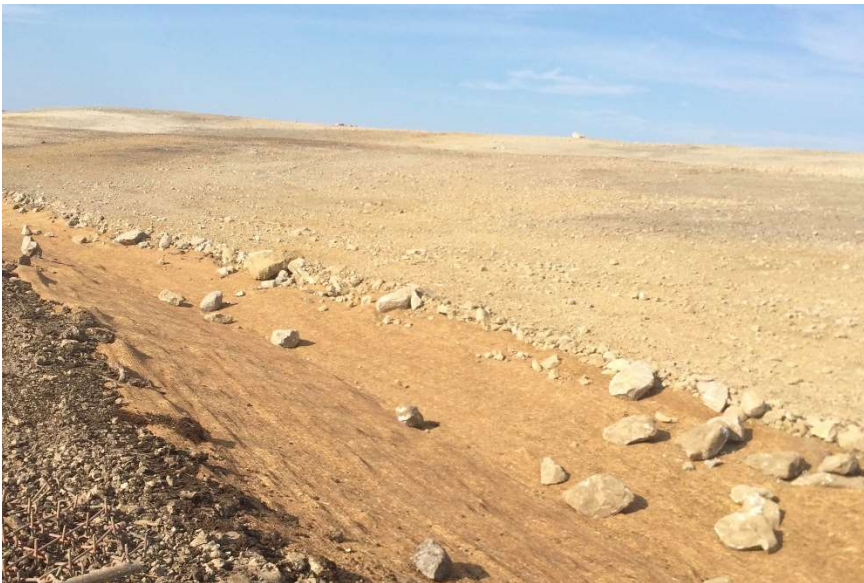
Erosion control blanket in channel. Note rocks pushed into channel to permit seeding of slopes.

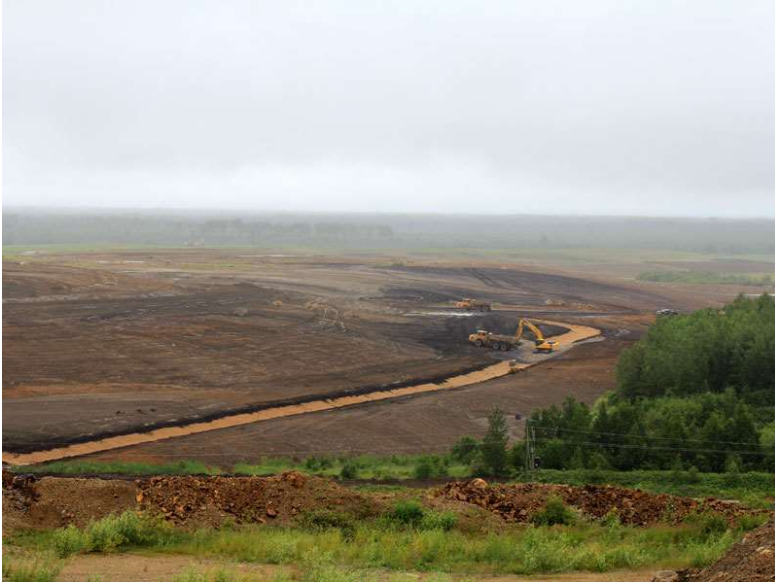
Fine graded and scarified area prior to seeding. Note erosion control blanket in channel. Seeding was scheduled in channels before the installation of the blanket. Seeding on slopes was scheduled after the installation of Rip Rap by the earthworks contractor.

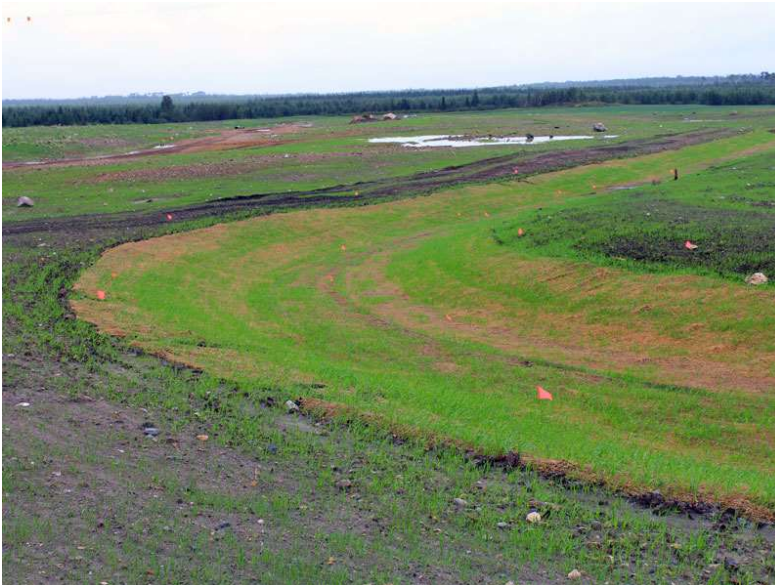
Early growth on slopes and within channels. Note wet conditions.

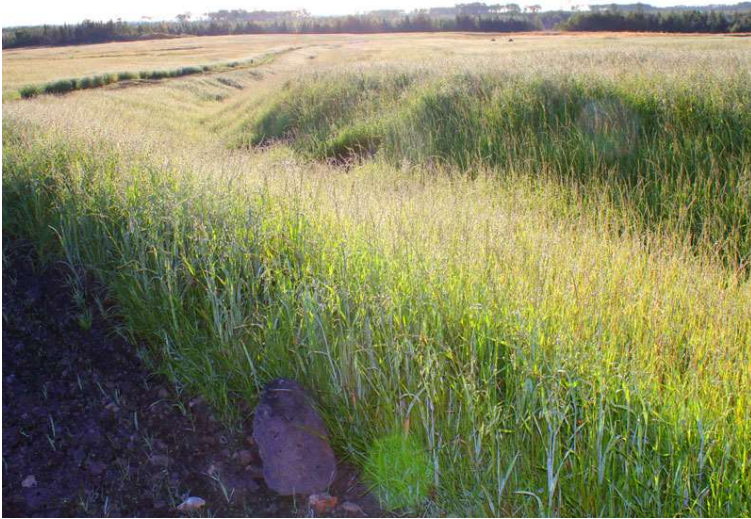
Same area as in previous picture at the end of the first growing season.

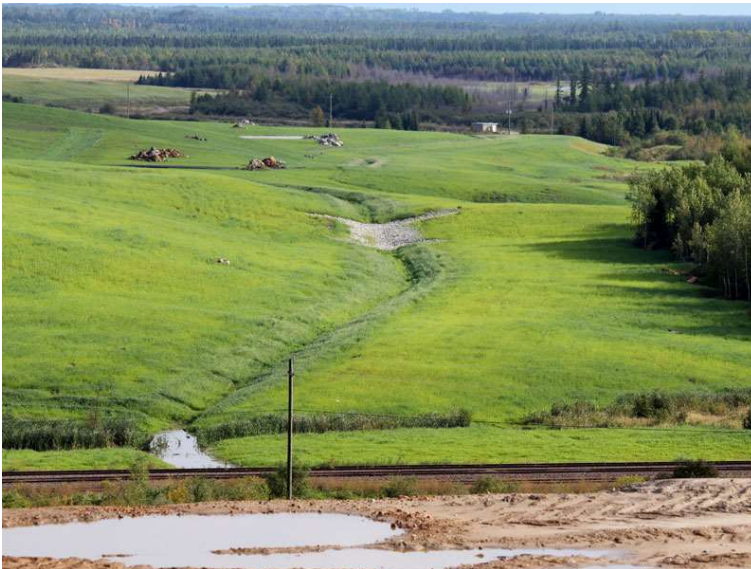
General overview of Rock Pile section after first growing season. Note clusters of oversize rocks. Smaller rocks are now hidden by vegetation.

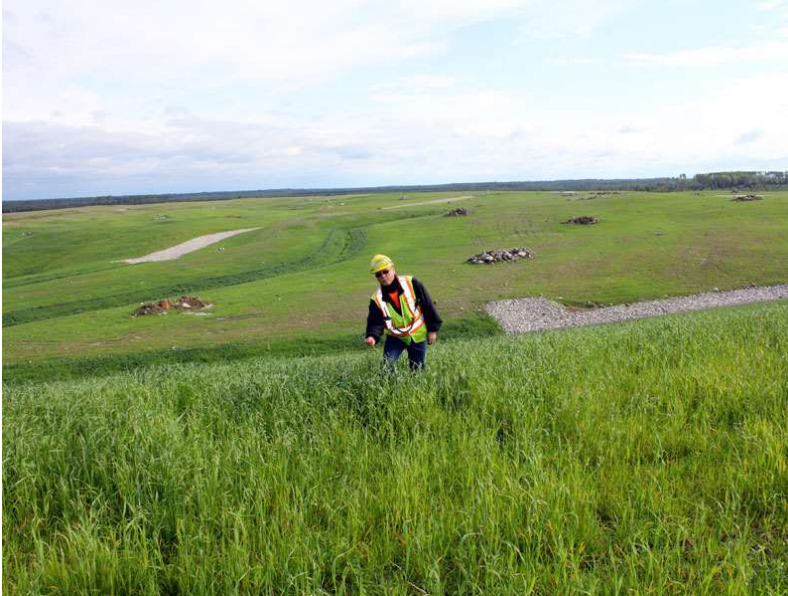
General overview of Rock
Pile section after first
growing season.

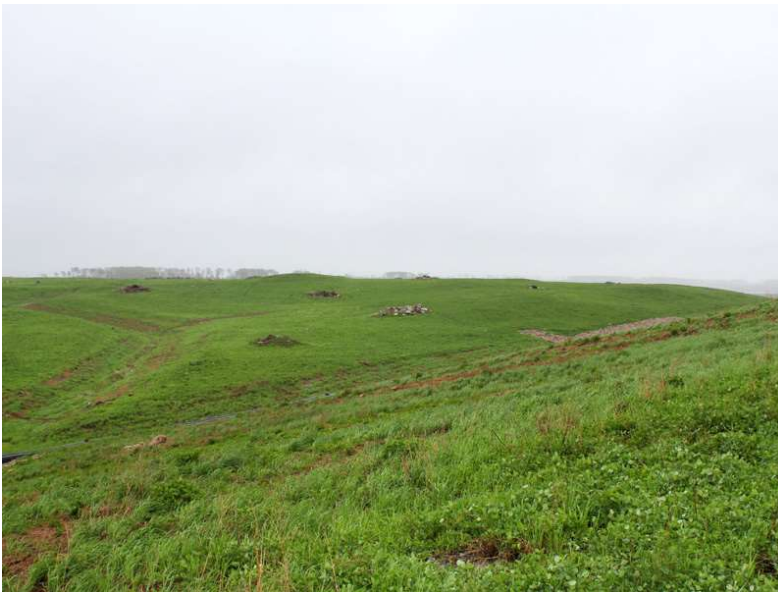
General overview of Rock
Pile section after first
growing season.

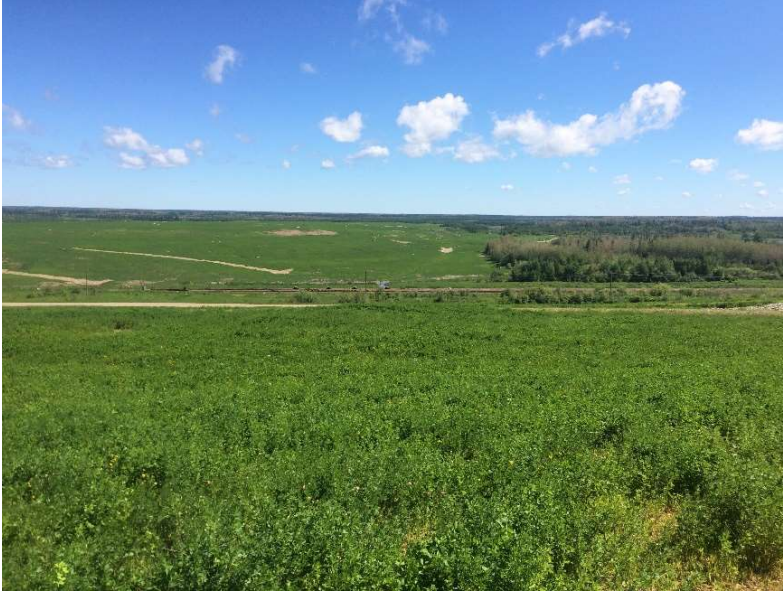
In distance is a general overview of Rock Pile section after 3 growing seasons. In foreground is the Clay pile after 2 growing seasons.

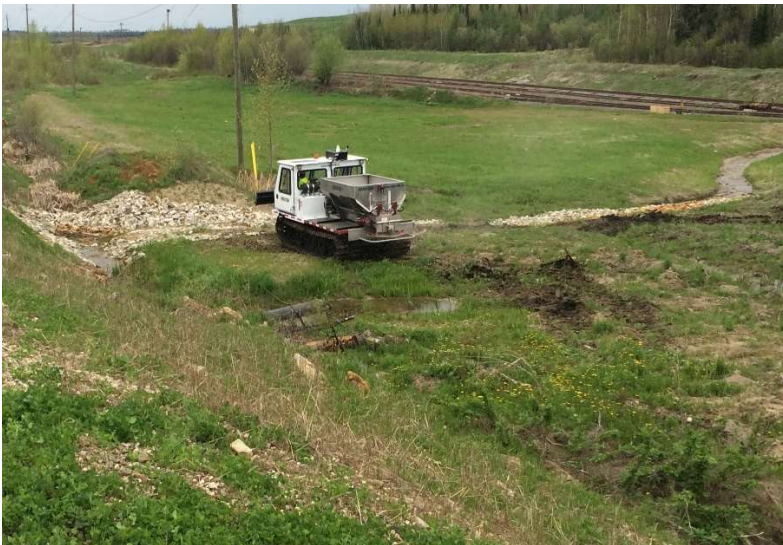
Use of Low ground pressure unit for swampy terrain sections.

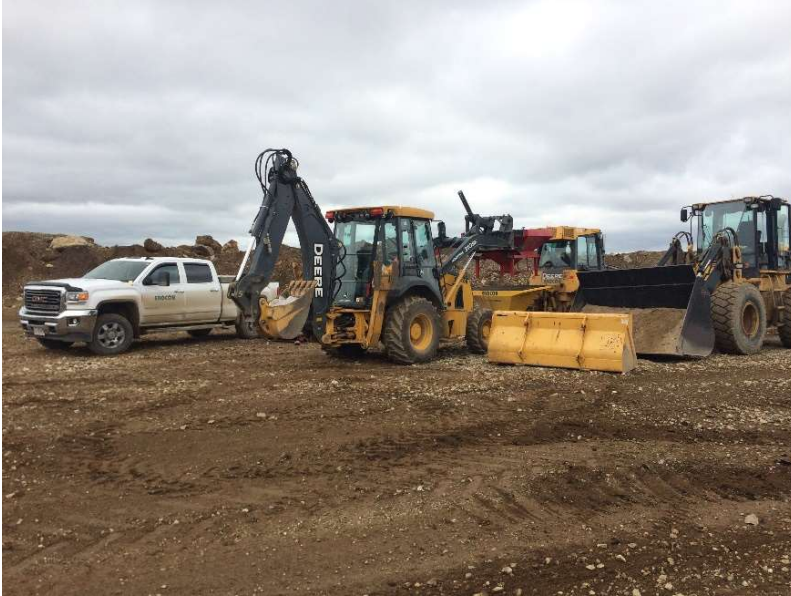
Loading of seed batch in hopper.

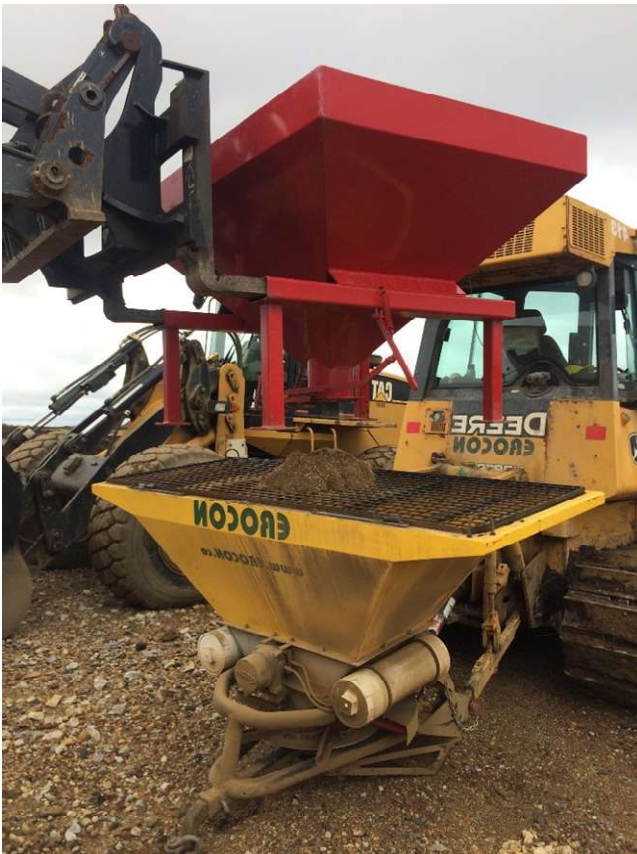
Loading of Stringy native seed mix which required the addition of sand and the use of auger spreader to be spread efficiently.

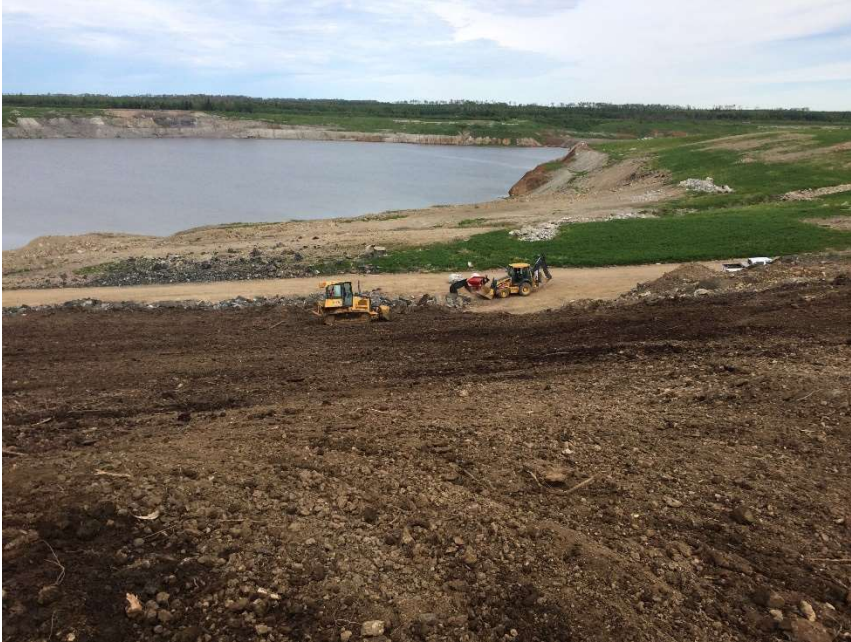
Seeding of future shorelines in flooded open pits on 3:1 slopes. As opposed to waste pile seeding the design did include a light amendment of topsoil.

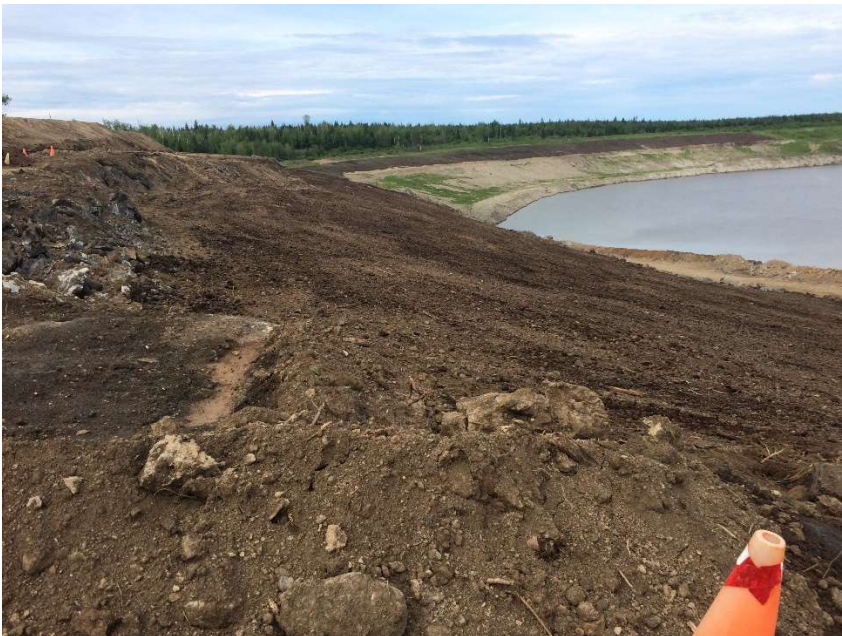
Overview of freshly seeded pit shoreline section.

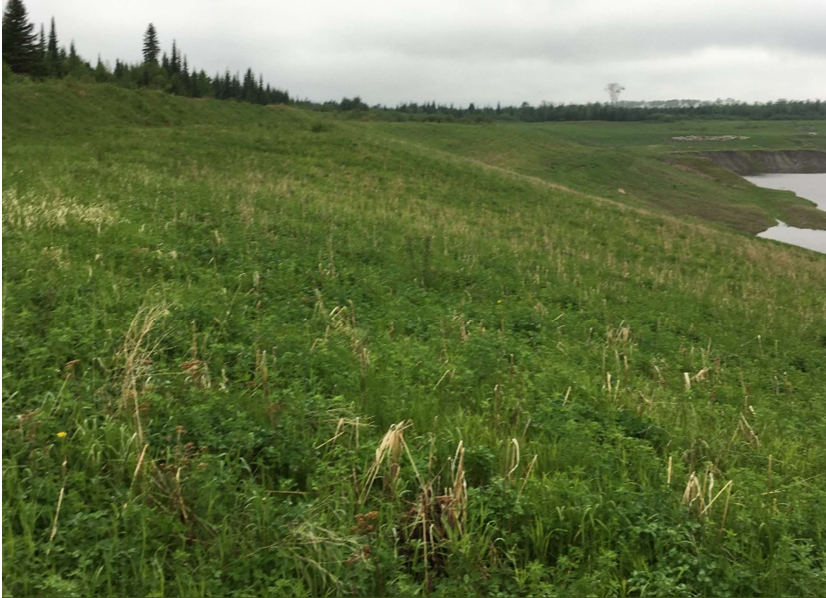
Pit shorelines after two growing seasons.

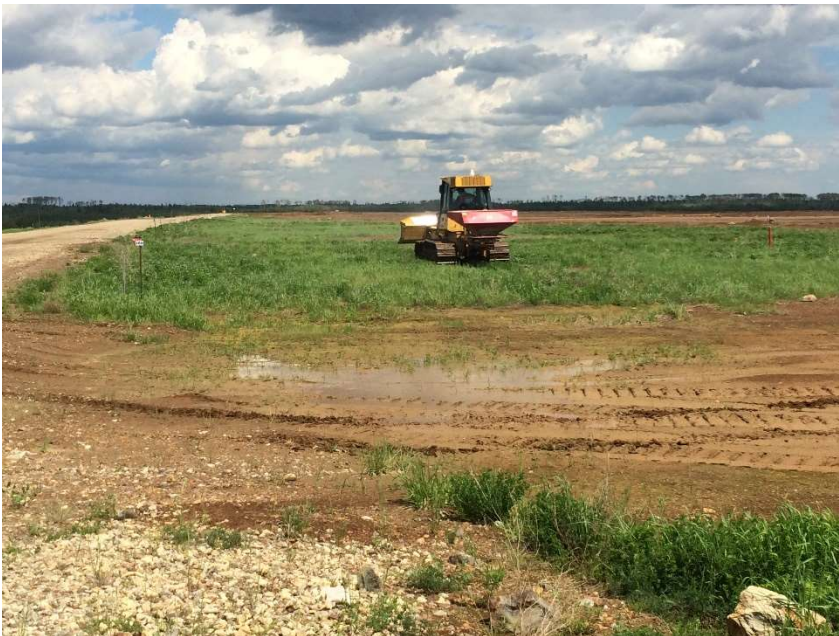
Re fertilizing tailings test plots as per client test protocols.
